# **Designated Substances Survey -Former Maple Syrup Factory - Lower Beverly Lake Park Road, Delta, Ontario**

June 9, 2023

Prepared for:  
Township of Rideau Lakes

Cambium Reference: 17181-002

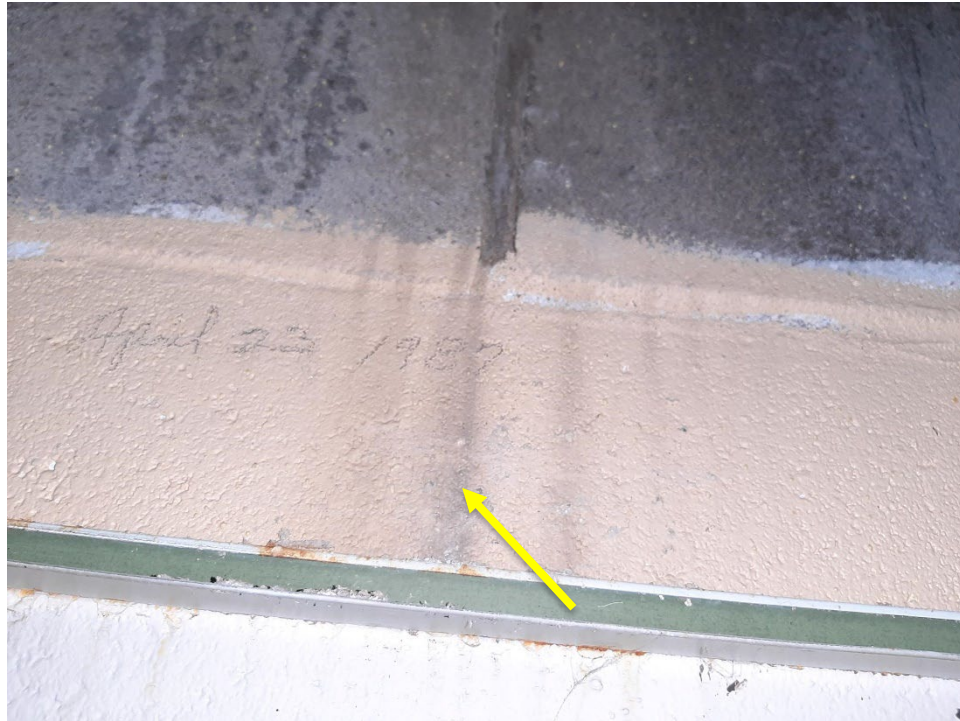
***Photo 1 – Mould growth on block wall.***

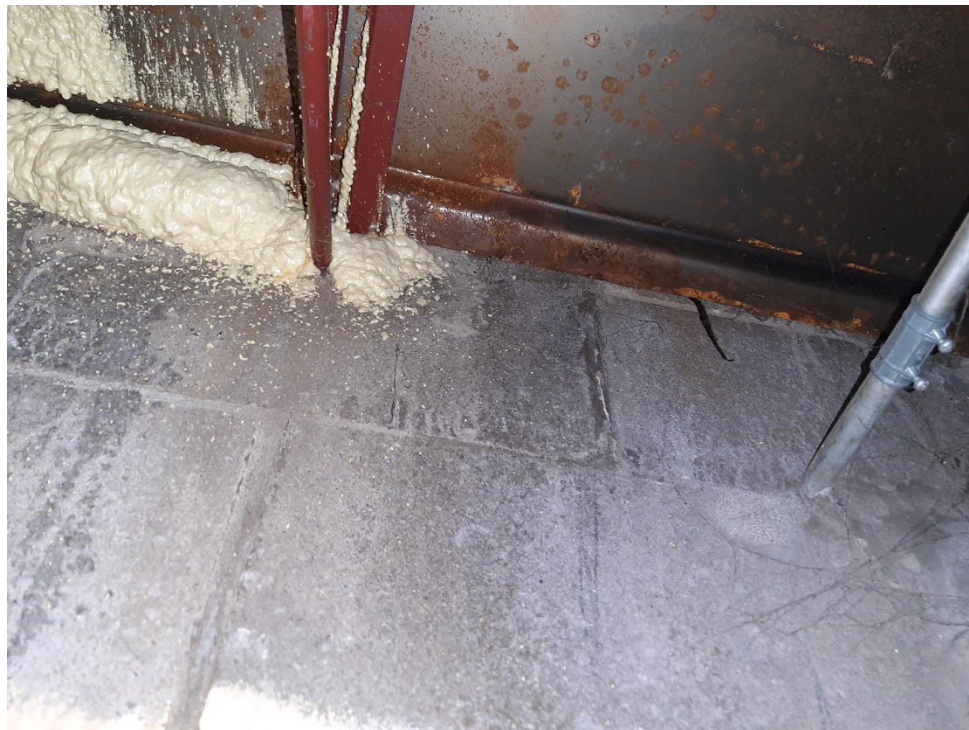
***Photo 2 – Mould growth on block wall.***

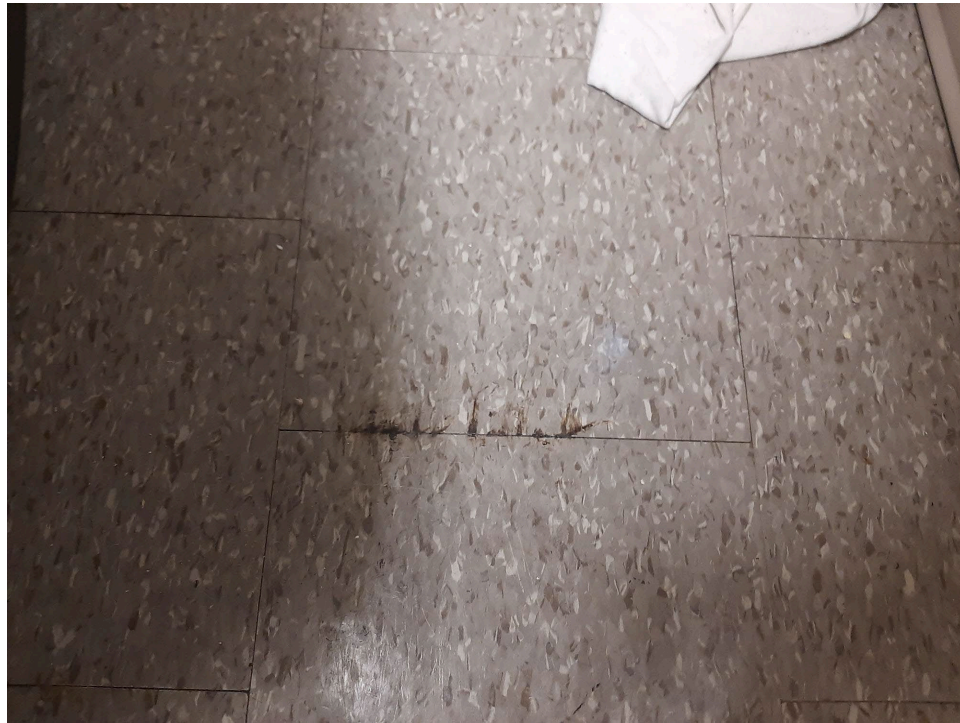
***Photo 3 – Black staining on vinyl floor tiles.***

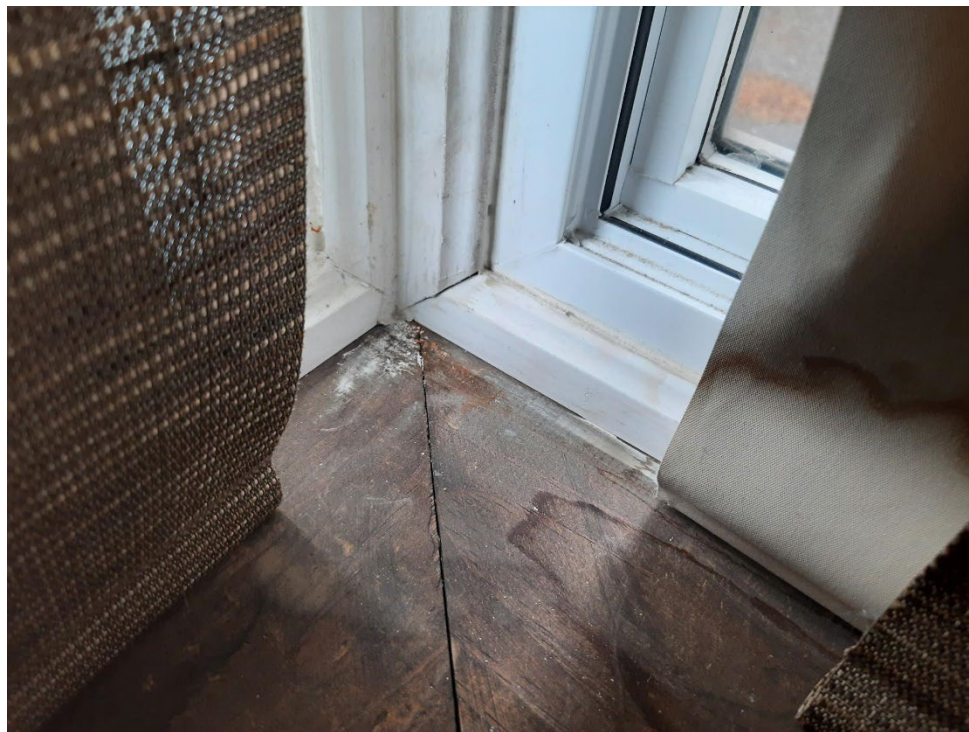
***Photo 4 – Water staining on window sill.***
