File: 12610

May 13, 2026

Re: Structural Review  
Fire Station No. 3/ Elgin Public Library  
26 Halladay St.  
Elgin, ON

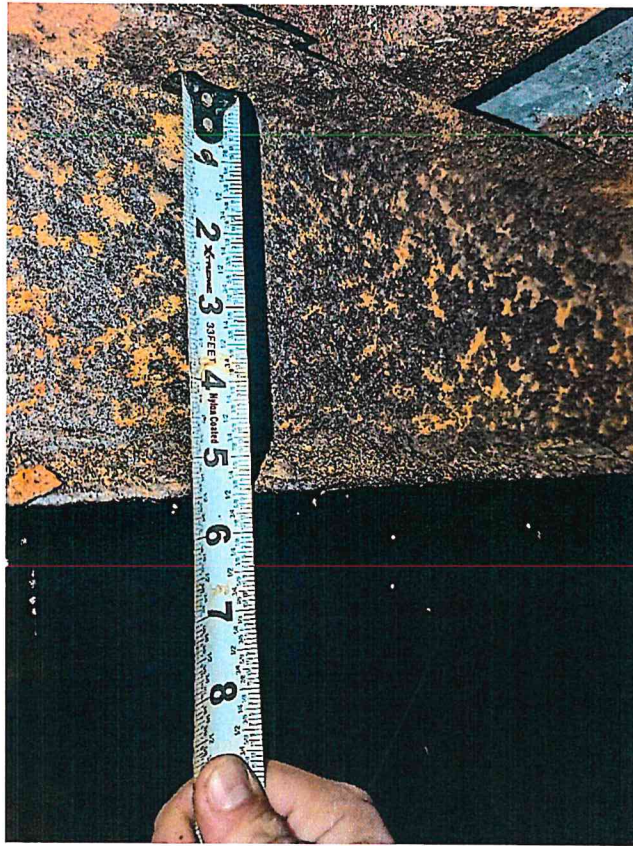
During our review, we completed a visual inspection of the metal deck, W8 support beam, and W4 column in the cistern. We also complete a scrape test on the beam to determine the level of sectional loss on the structural members at the critical tension section. Our results showed an average of 50% section loss in the beam's bottom flange. We also noted that the deck and concrete were in very poor condition at the hatch area, which is the primary entrance to the library.

Scrape Test – Showing 50% Section Lose

It is our opinion that the remediation should be implemented within 14 weeks, on September 1, 2026. It is possible to extend this timeframe by limiting the floor loads; however, this is not recommended.

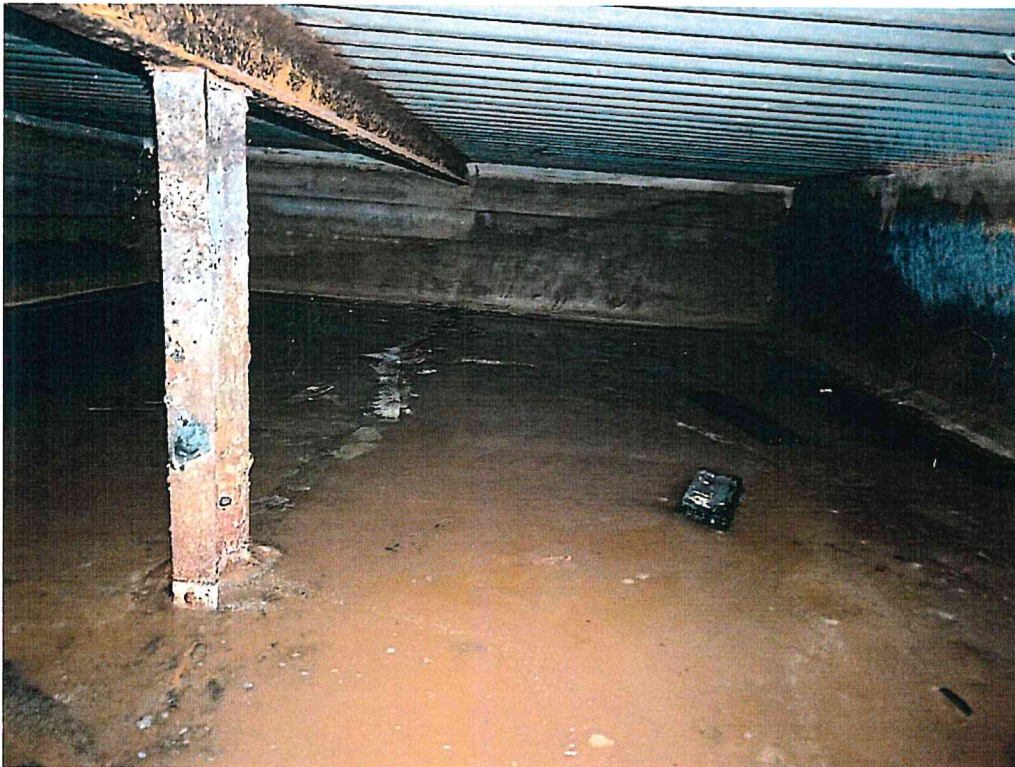
Pan in fair condition – Column and Beam in Poor Condition

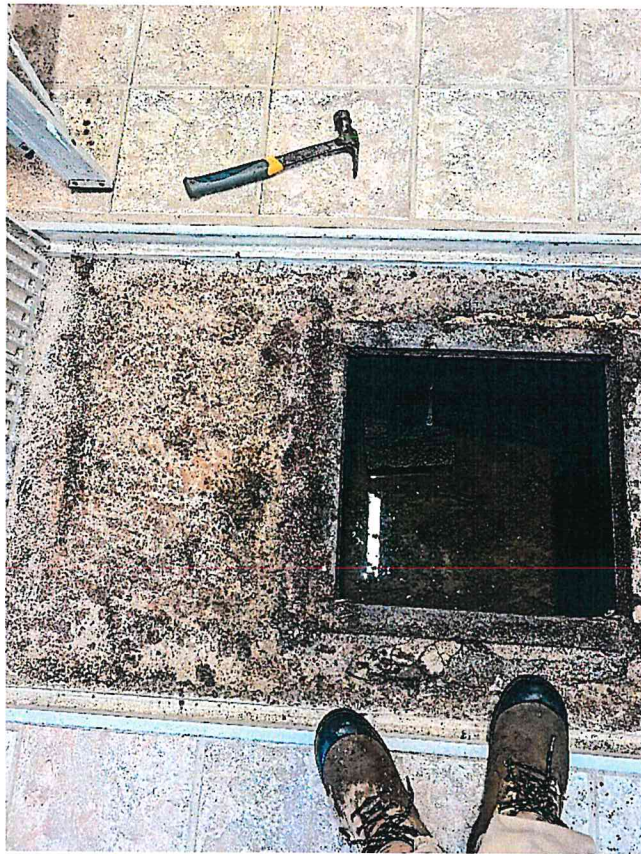
Rot in Concrete and Frame at Entrance

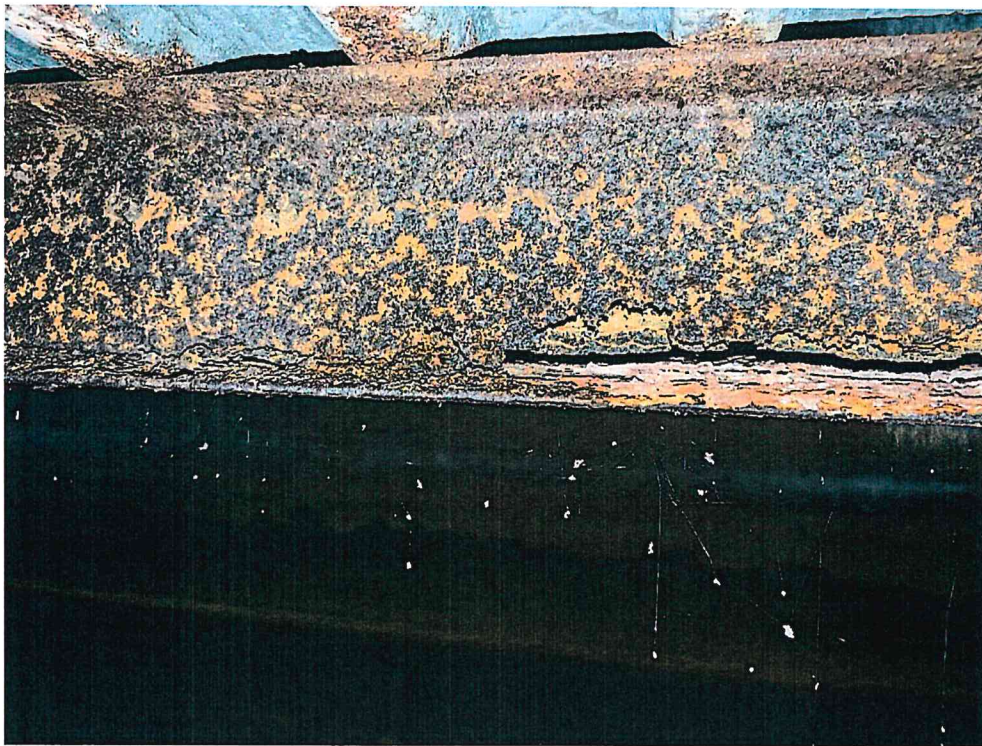
Scaling of the Beam Supporting Metal Pan

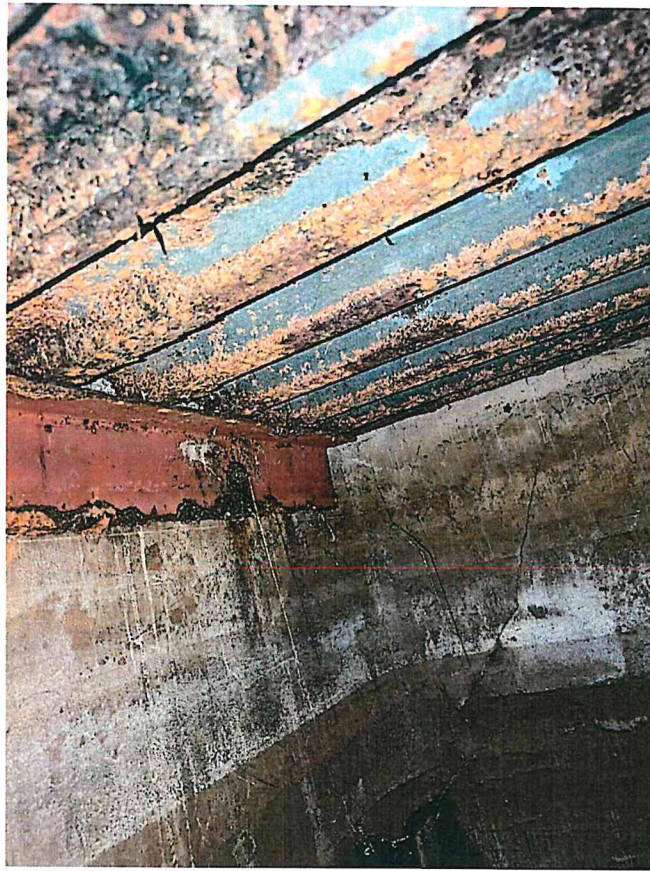
Severe Corrosion of the Metal Pan and Entrance
