Roof Asset Management Program

Roof Repair RFT - Ron E. Holman Complex 2026

February 26, 2026

FACILITY: Ronald E Holman Complex	ROOF SECTION: Roof 3	TITLE: Roof Repair Photo Report	DATE: 02/26/2026
--	-----------------------------	--	-------------------------

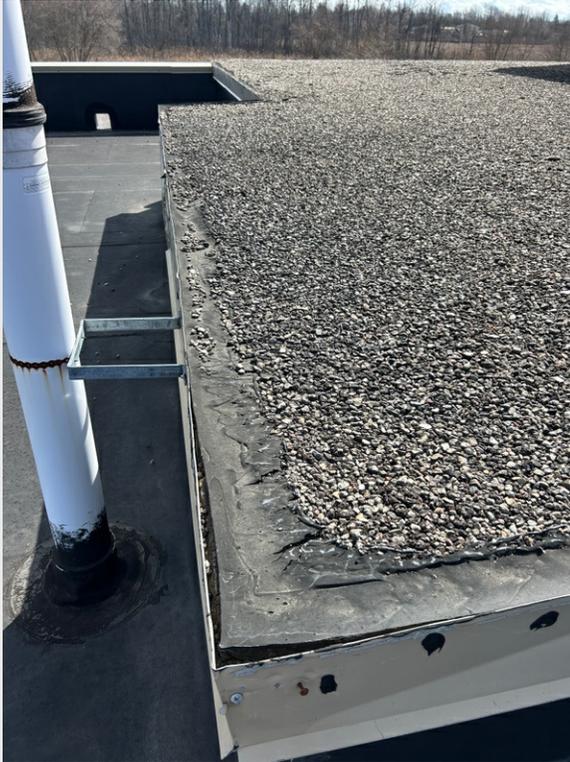
3

Closeup of gravel stop condition. Corner of membrane has lost adhesion and is in failed condition. Flashing membrane has lost its gravel coverage and requires new surfacing including resat & pea gravel.

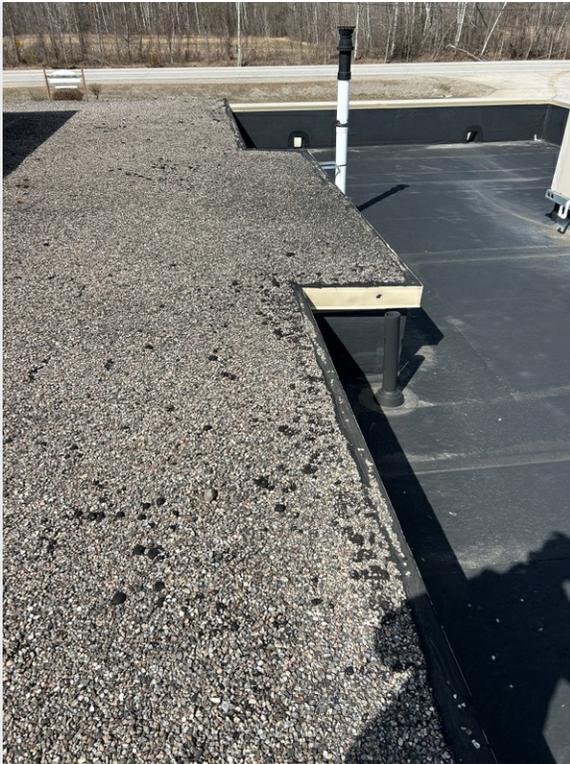
4

General view of the gravel stop condition

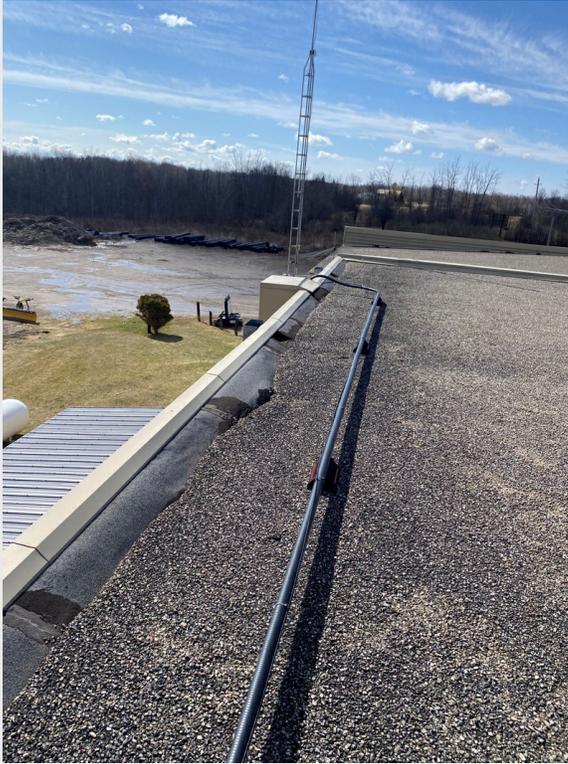
25

East side of roof 4.0 showing flashings to be replaced.
