FOUNDATION INVESTIGATION AND DESIGN REPORT TOWNLINE ROAD BRIDGE (SN 16-511) – TOWNSHIP OF ELIZABETHTOWN-KITLEY & TOWNSHIP OF RIDEAU LAKES, ONTARIO.

FOUNDATION INVESTIGATION AND DESIGN REPORT

Townline Road Bridge (SN16-511)

Township of Elizabethtown-Kitley & Township of Rideau Lakes, ONTARIO.

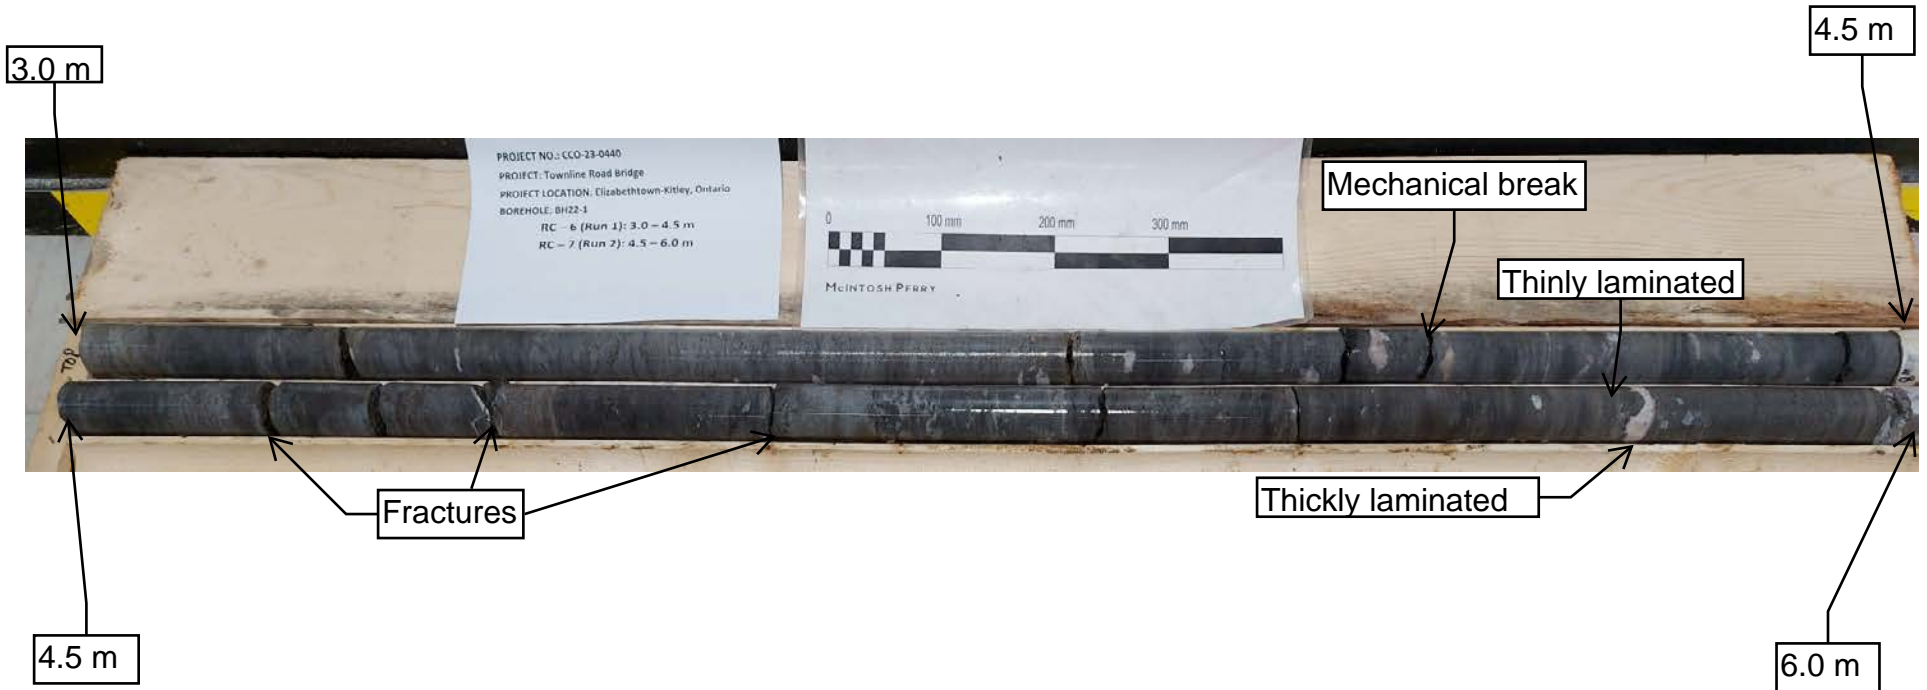
Figure No.: 5

BH22-1
Townline Road, South Elmsley.

Horizontally interbedded limestone and dolostone, light to dark grey, laminated, slightly to moderately fracture. Possible mineral composition: Calcite, and dolomite.

Bedrock was encountered in both boreholes at a depth of $\approx 2.9 - 3.0$ m bgs. The properties of the bedrock encountered in both boreholes indicated to dolostone with thinly to thickly horizontally laminated and bedded sandstone to minor shale deposits, light to dark grey. The structural integrity of the rock mass indicated to some horizontal fractures, and joint discontinuities, with occasional mechanical breaks caused by the rock coring activity. The rock core sample description is shown in Table 5-3, and images of the rock core are shown in Figures 5 and 6, Appendix D.

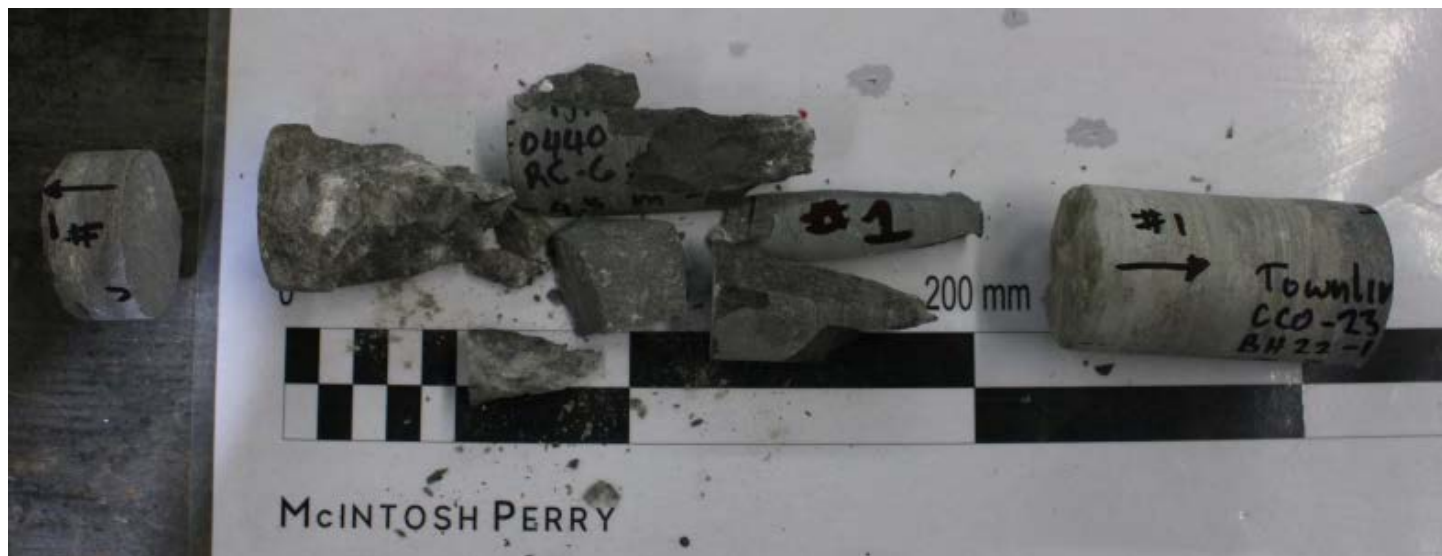
Figure No.: 7

Core #	RC Sample #	RUN #	Depth (m)	Diameter (mm)	Thickness/ Height (mm)	Density (kg/m ³)	Compressive Strength (MPa)	Mass of Core (g)
1	BH22-1 RC-6	1	3.0 - 4.5	47	106	2770	208	508

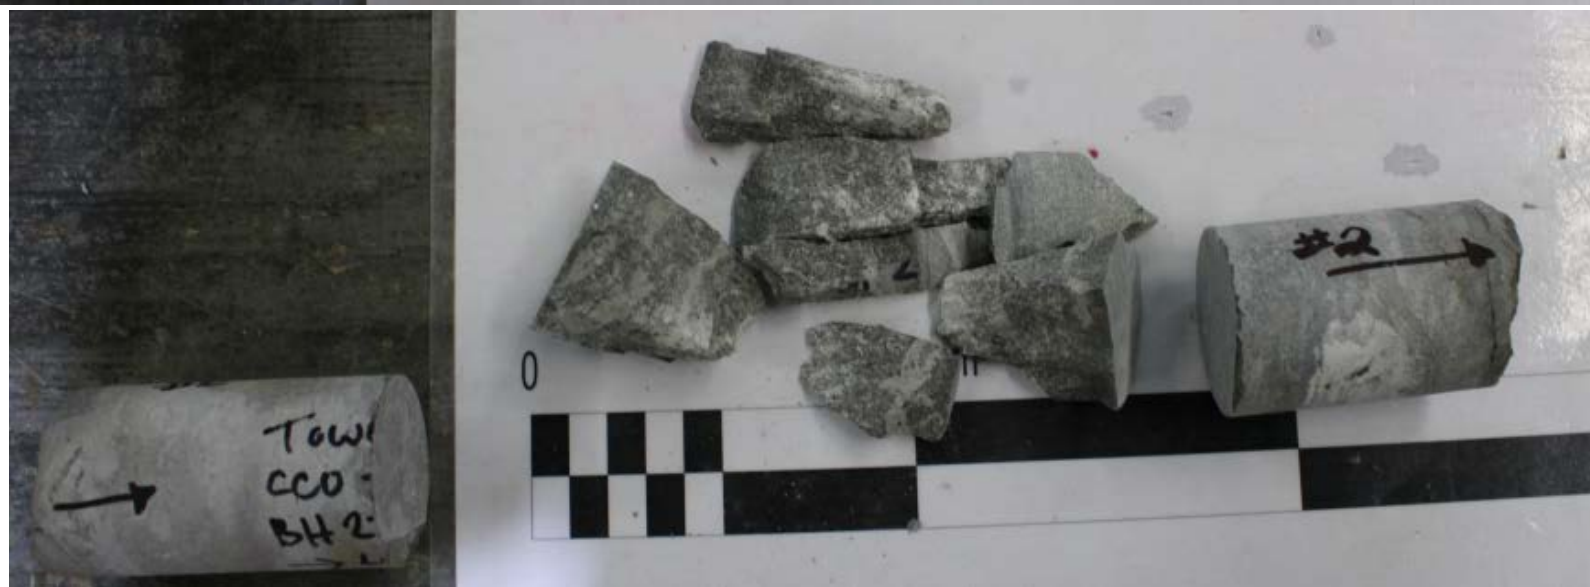
Figure No.: 8

Core #	RC Sample #	RUN #	Depth (m)	Diameter (mm)	Thickness/ Height (mm)	Density (kg/m ³)	Compressive Strength (MPa)	Mass of Core (g)
2	BH22-1 RC-7	2	4.5 - 6.0	47	107	2764	218	518

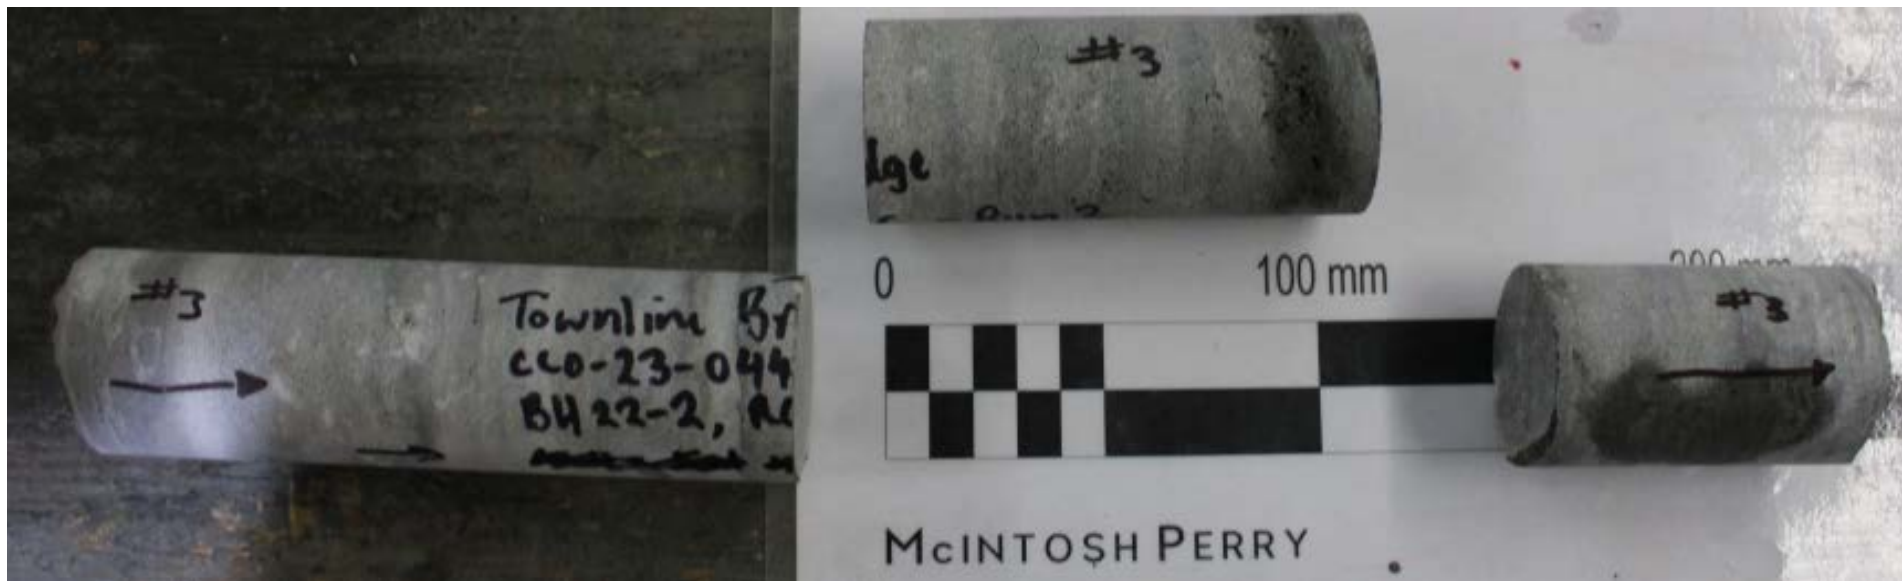
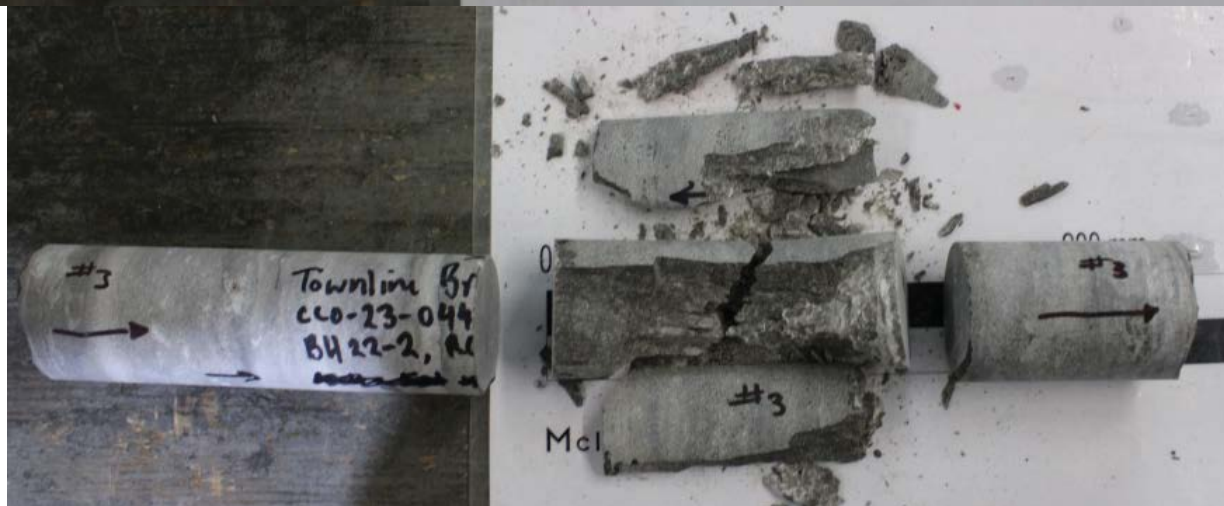
Figure No.: 9

Core #	RC Sample #	RUN #	Depth (m)	Diameter (mm)	Thickness/Height (mm)	Density (kg/m ³)	Compressive Strength (MPa)	Mass of Core (g)
3	BH22-2 RC-6	2	2.9 - 404	47	109	2760	139	525

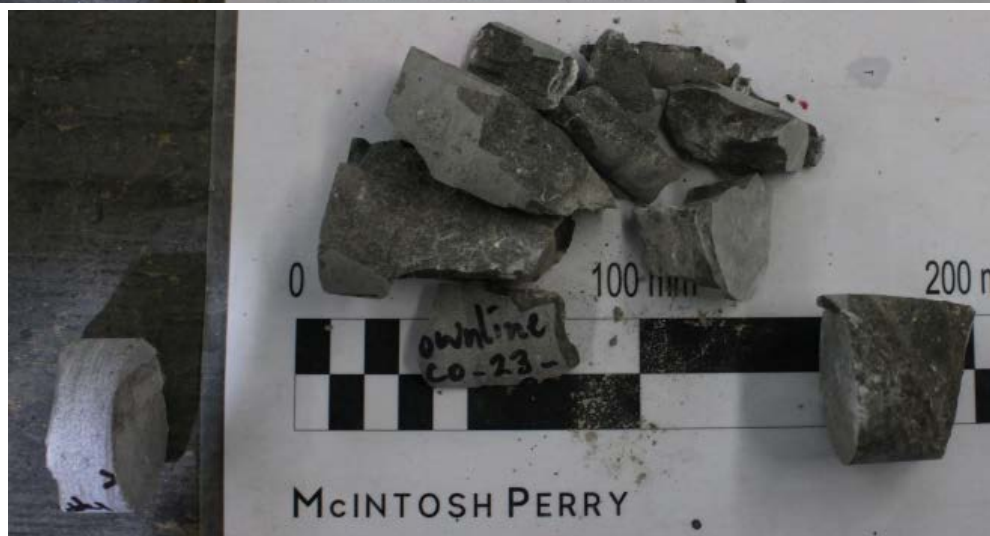
Figure No.: 10

Core #	RC Sample #	RUN #	Depth (m)	Diameter (mm)	Thickness/Height (mm)	Density (kg/m ³)	Compressive Strength (MPa)	Mass of Core (g)
4	BH22-2 RC-7	3	4.4 - 5.1	47	108	2751	227	518

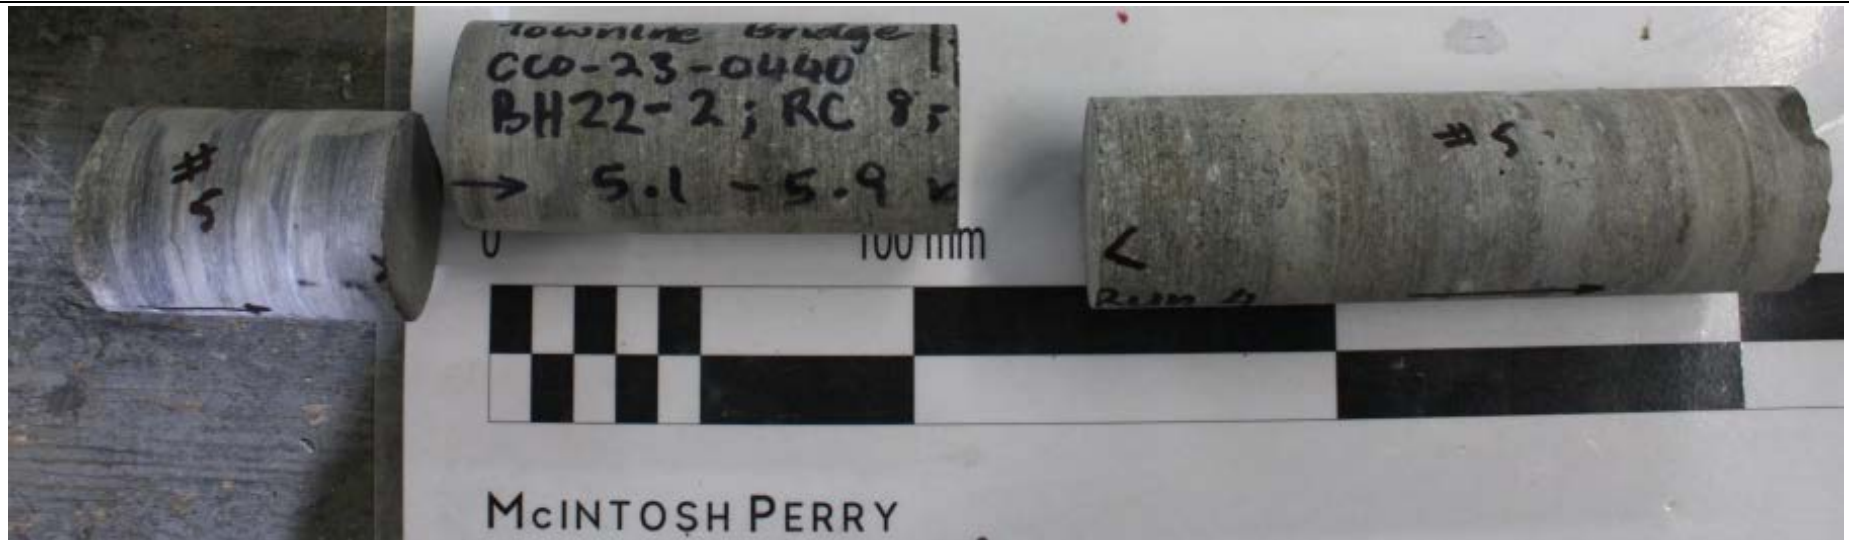
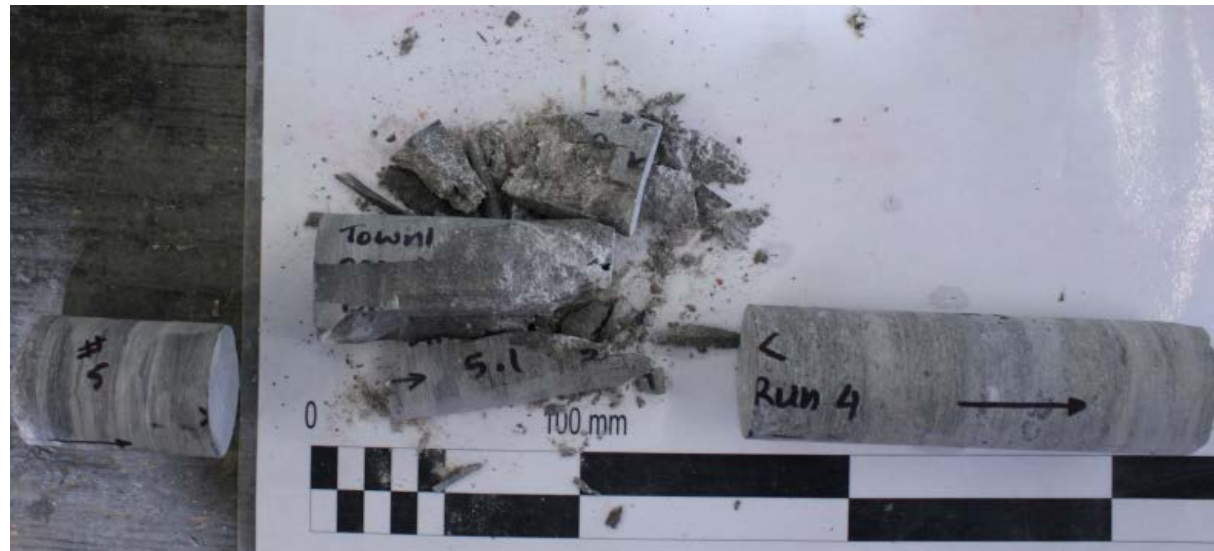
Figure No.: 11

Core #	RC Sample #	RUN #	Depth (m)	Diameter (mm)	Thickness/ Height (mm)	Density (kg/m ³)	Compressive Strength (MPa)	Mass of Core (g)
5	BH22-2 RC-8	4	5.1 - 5.9	47	109	2713	106	519

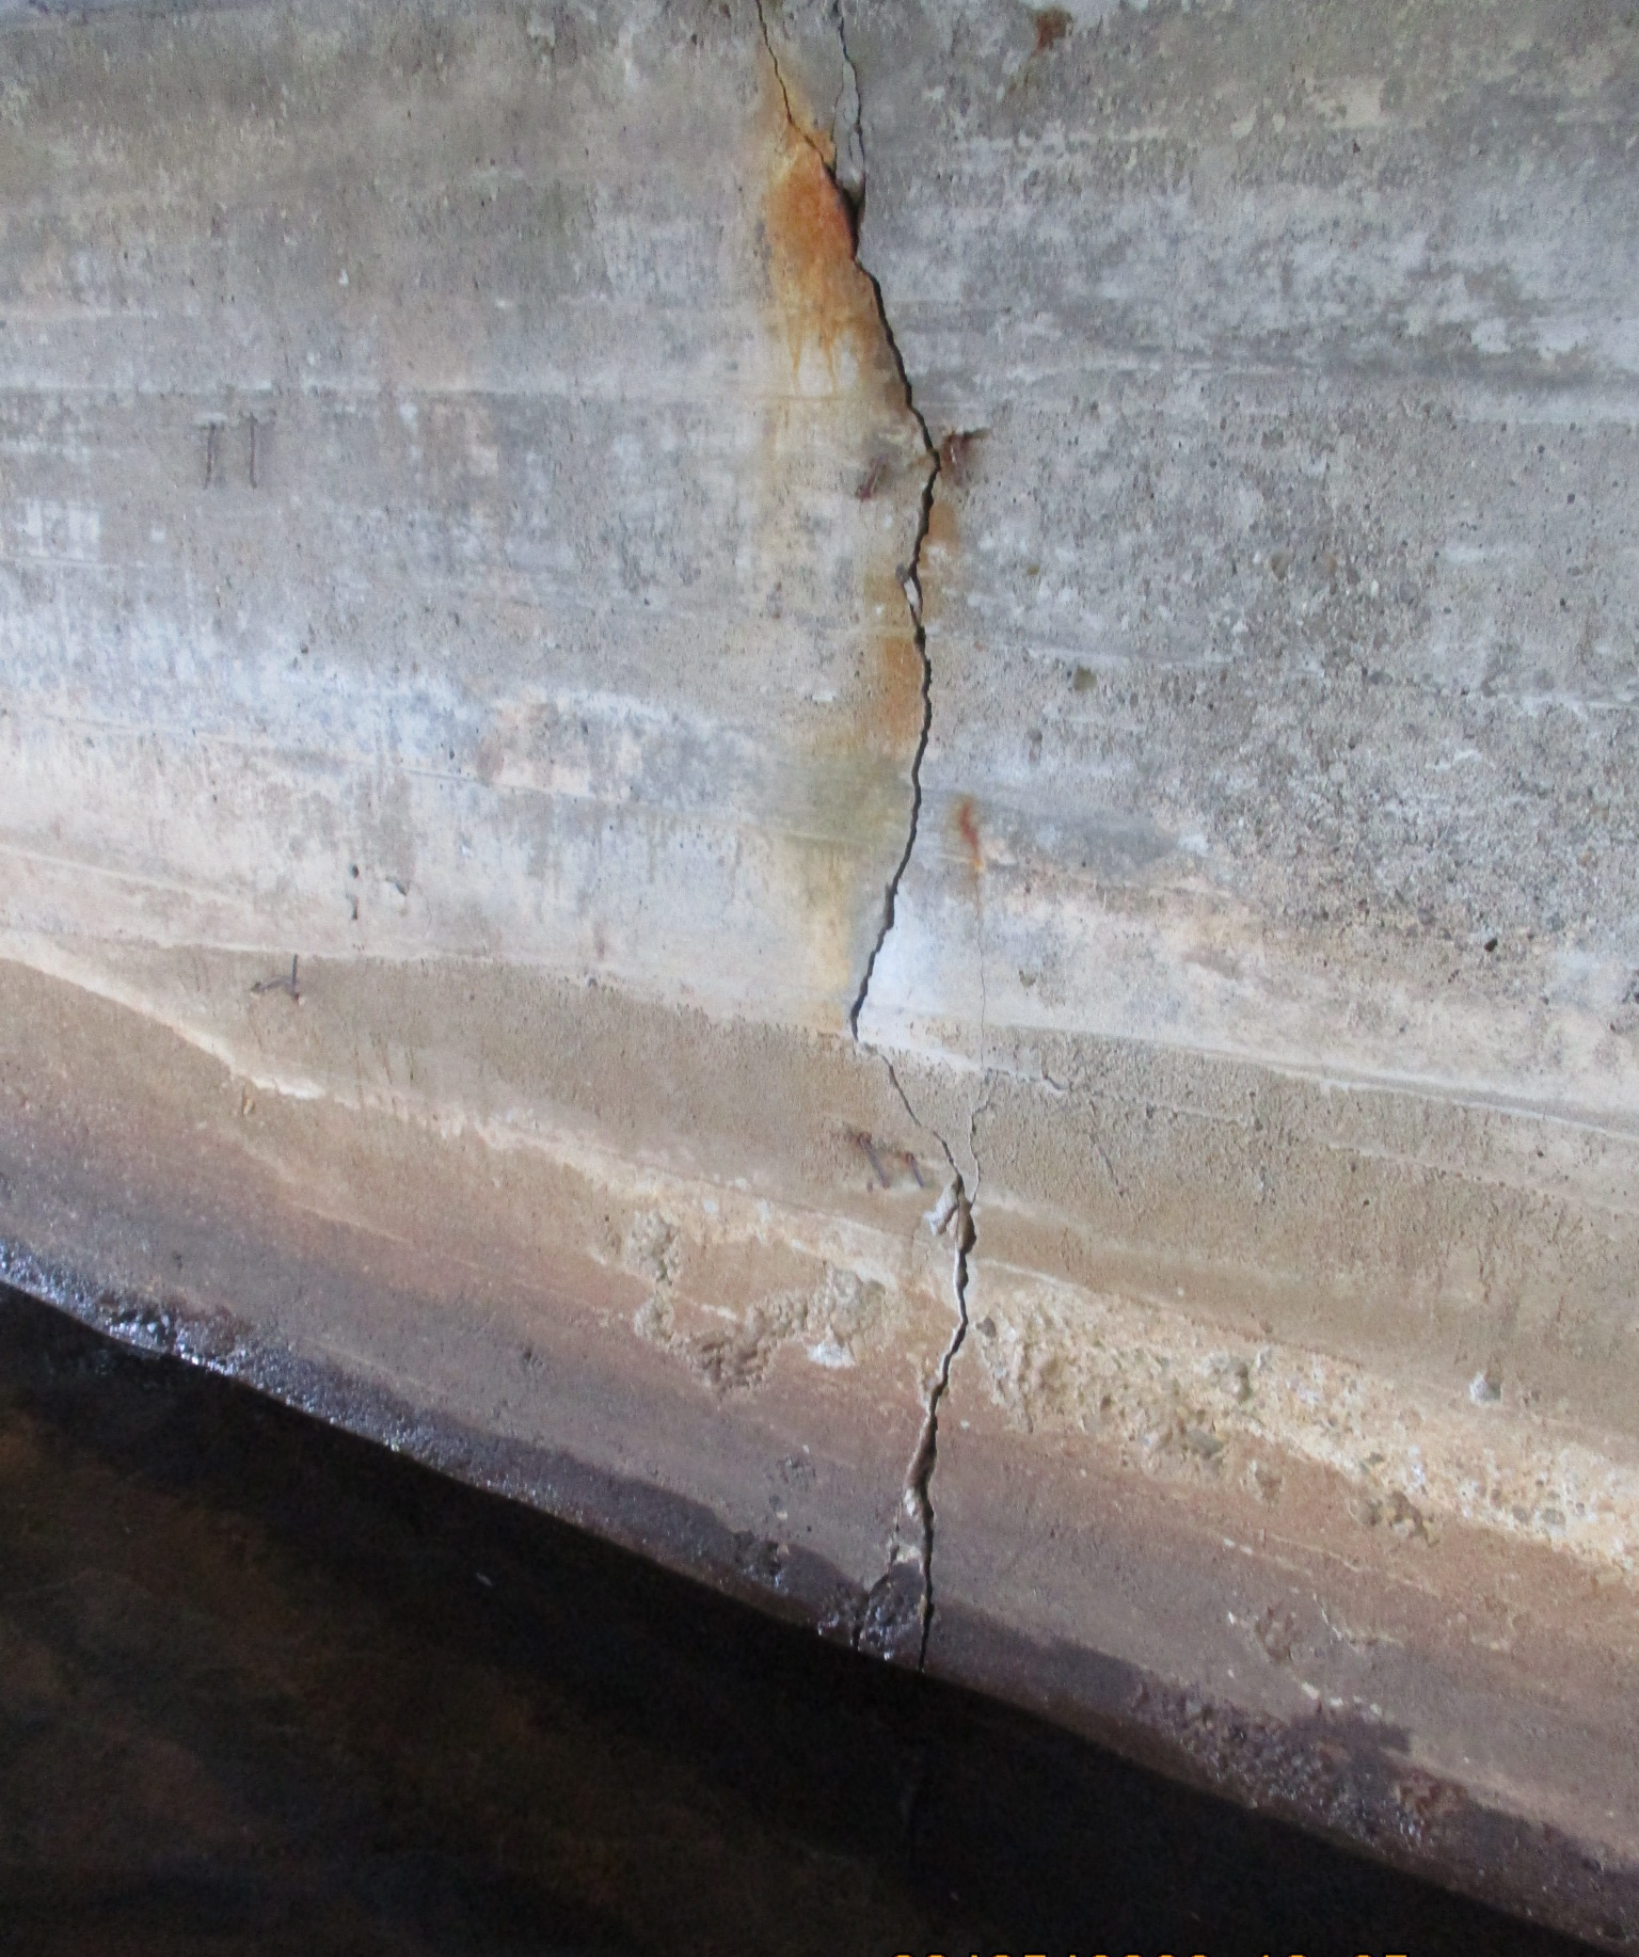
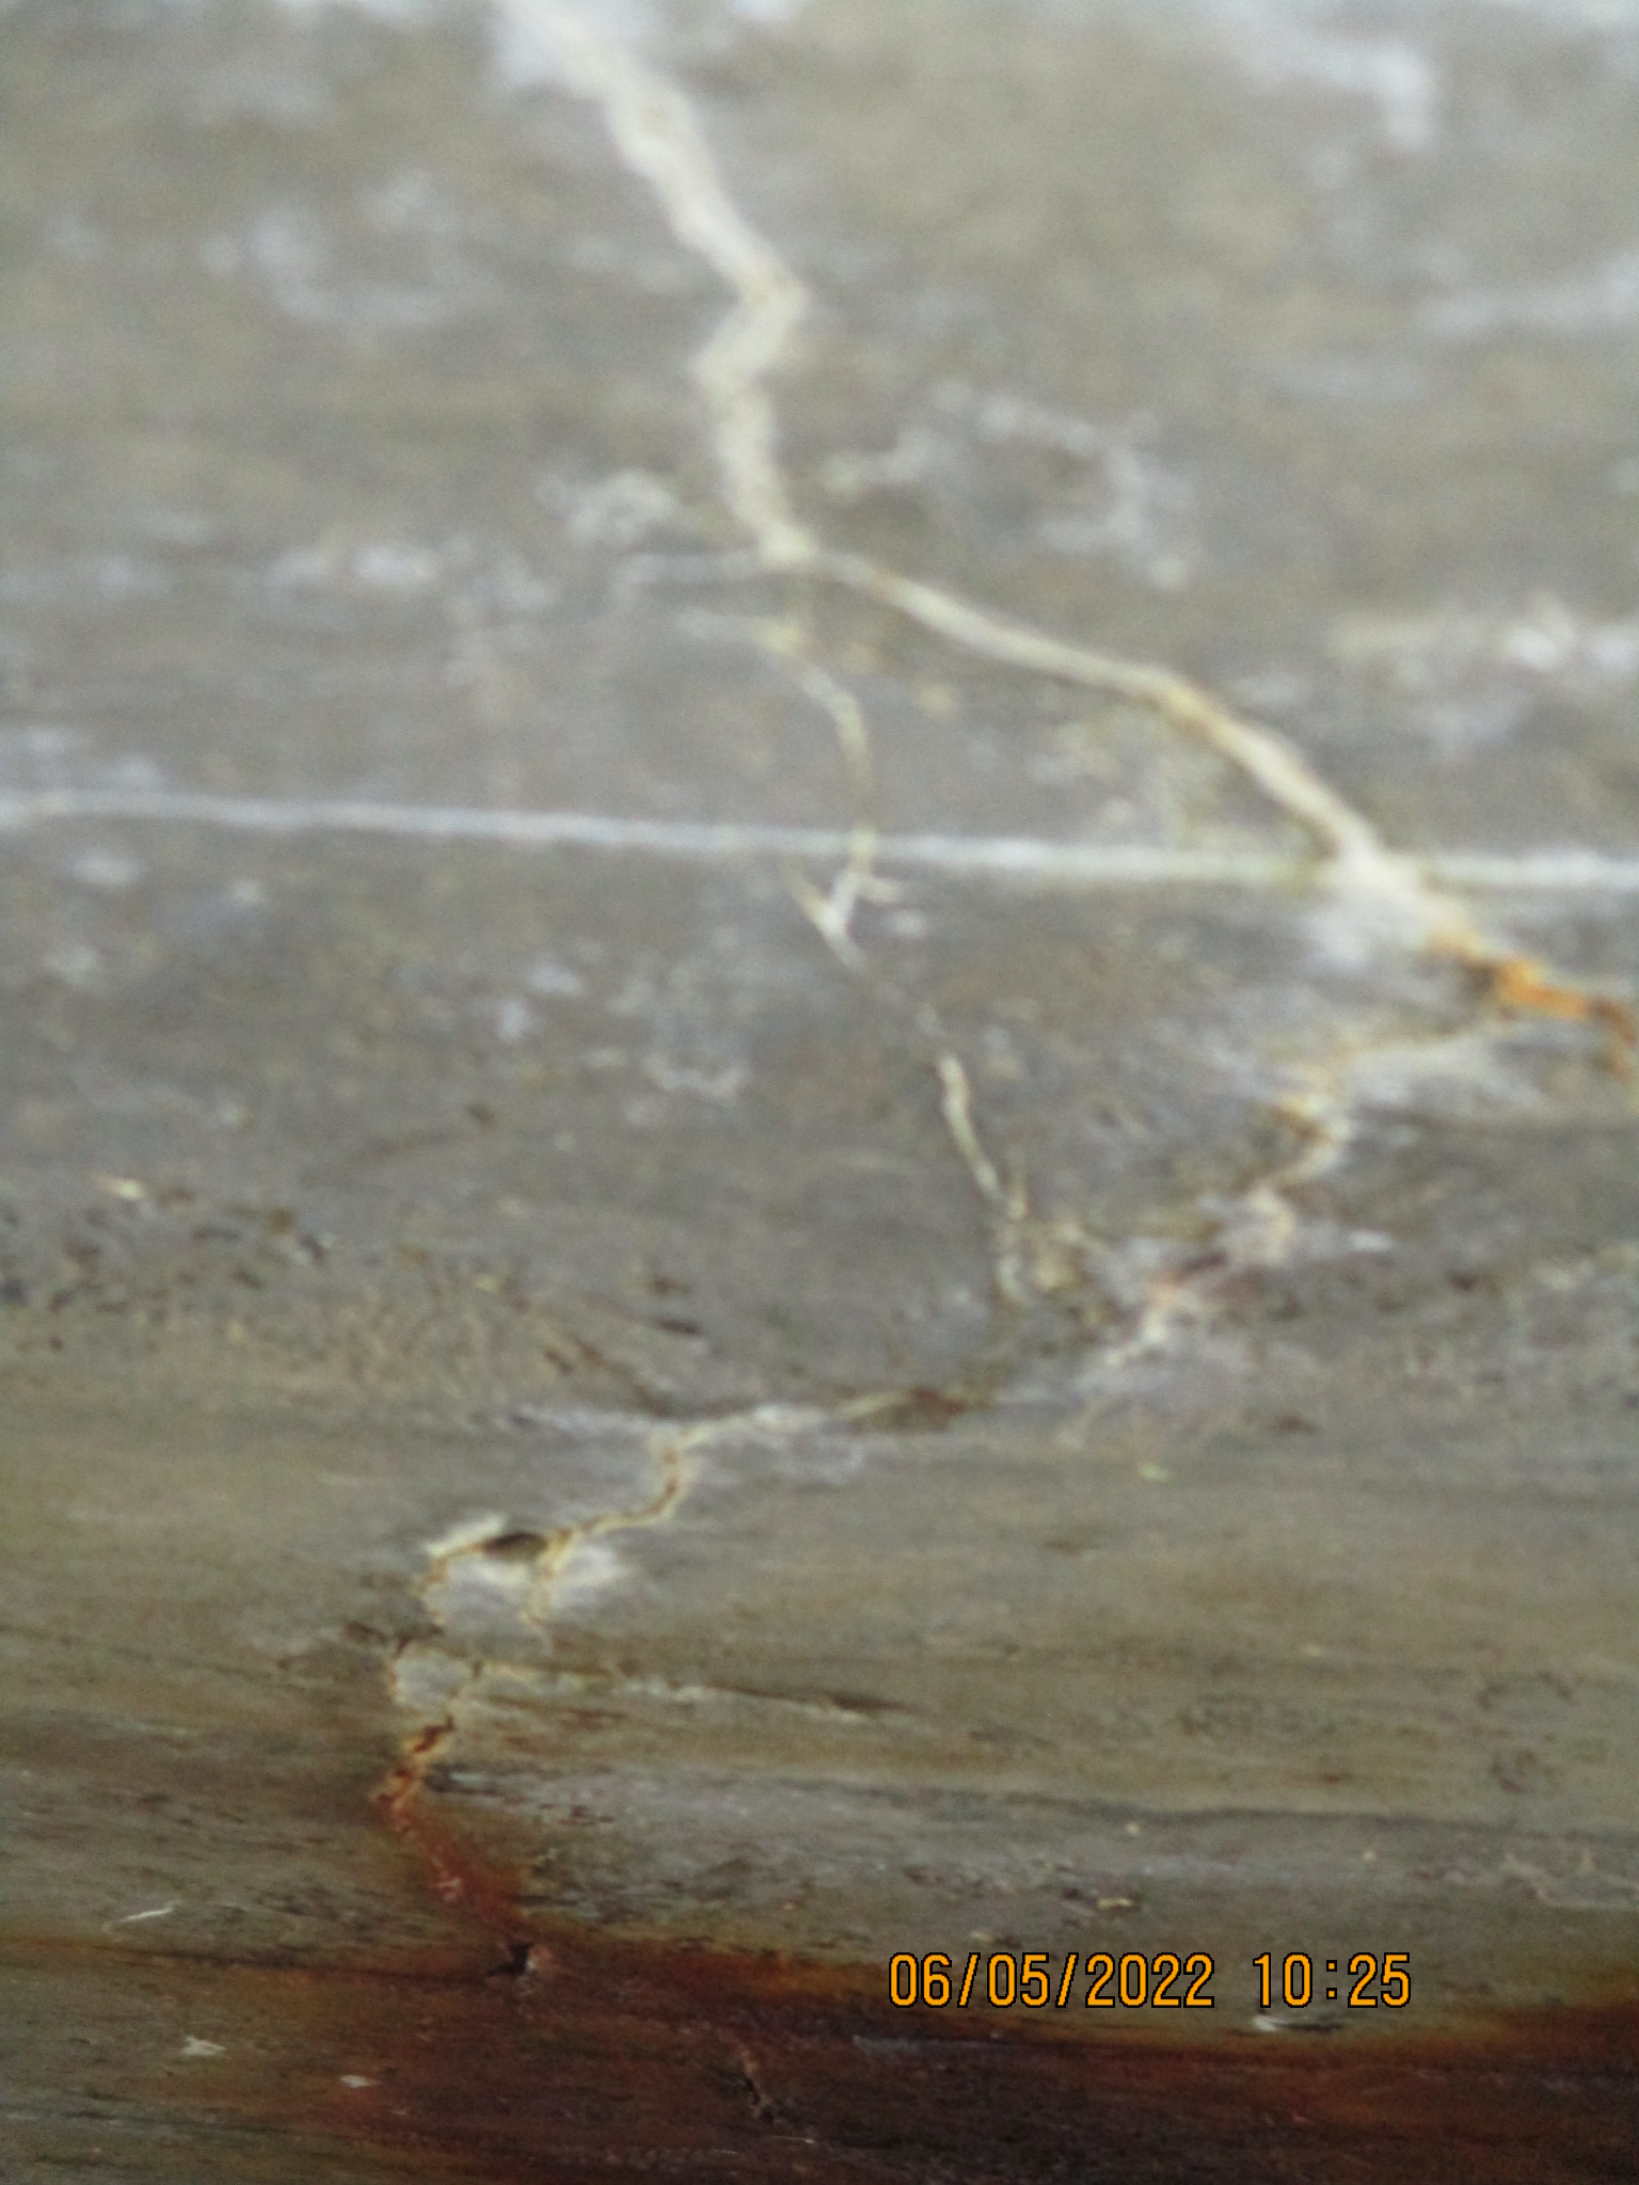
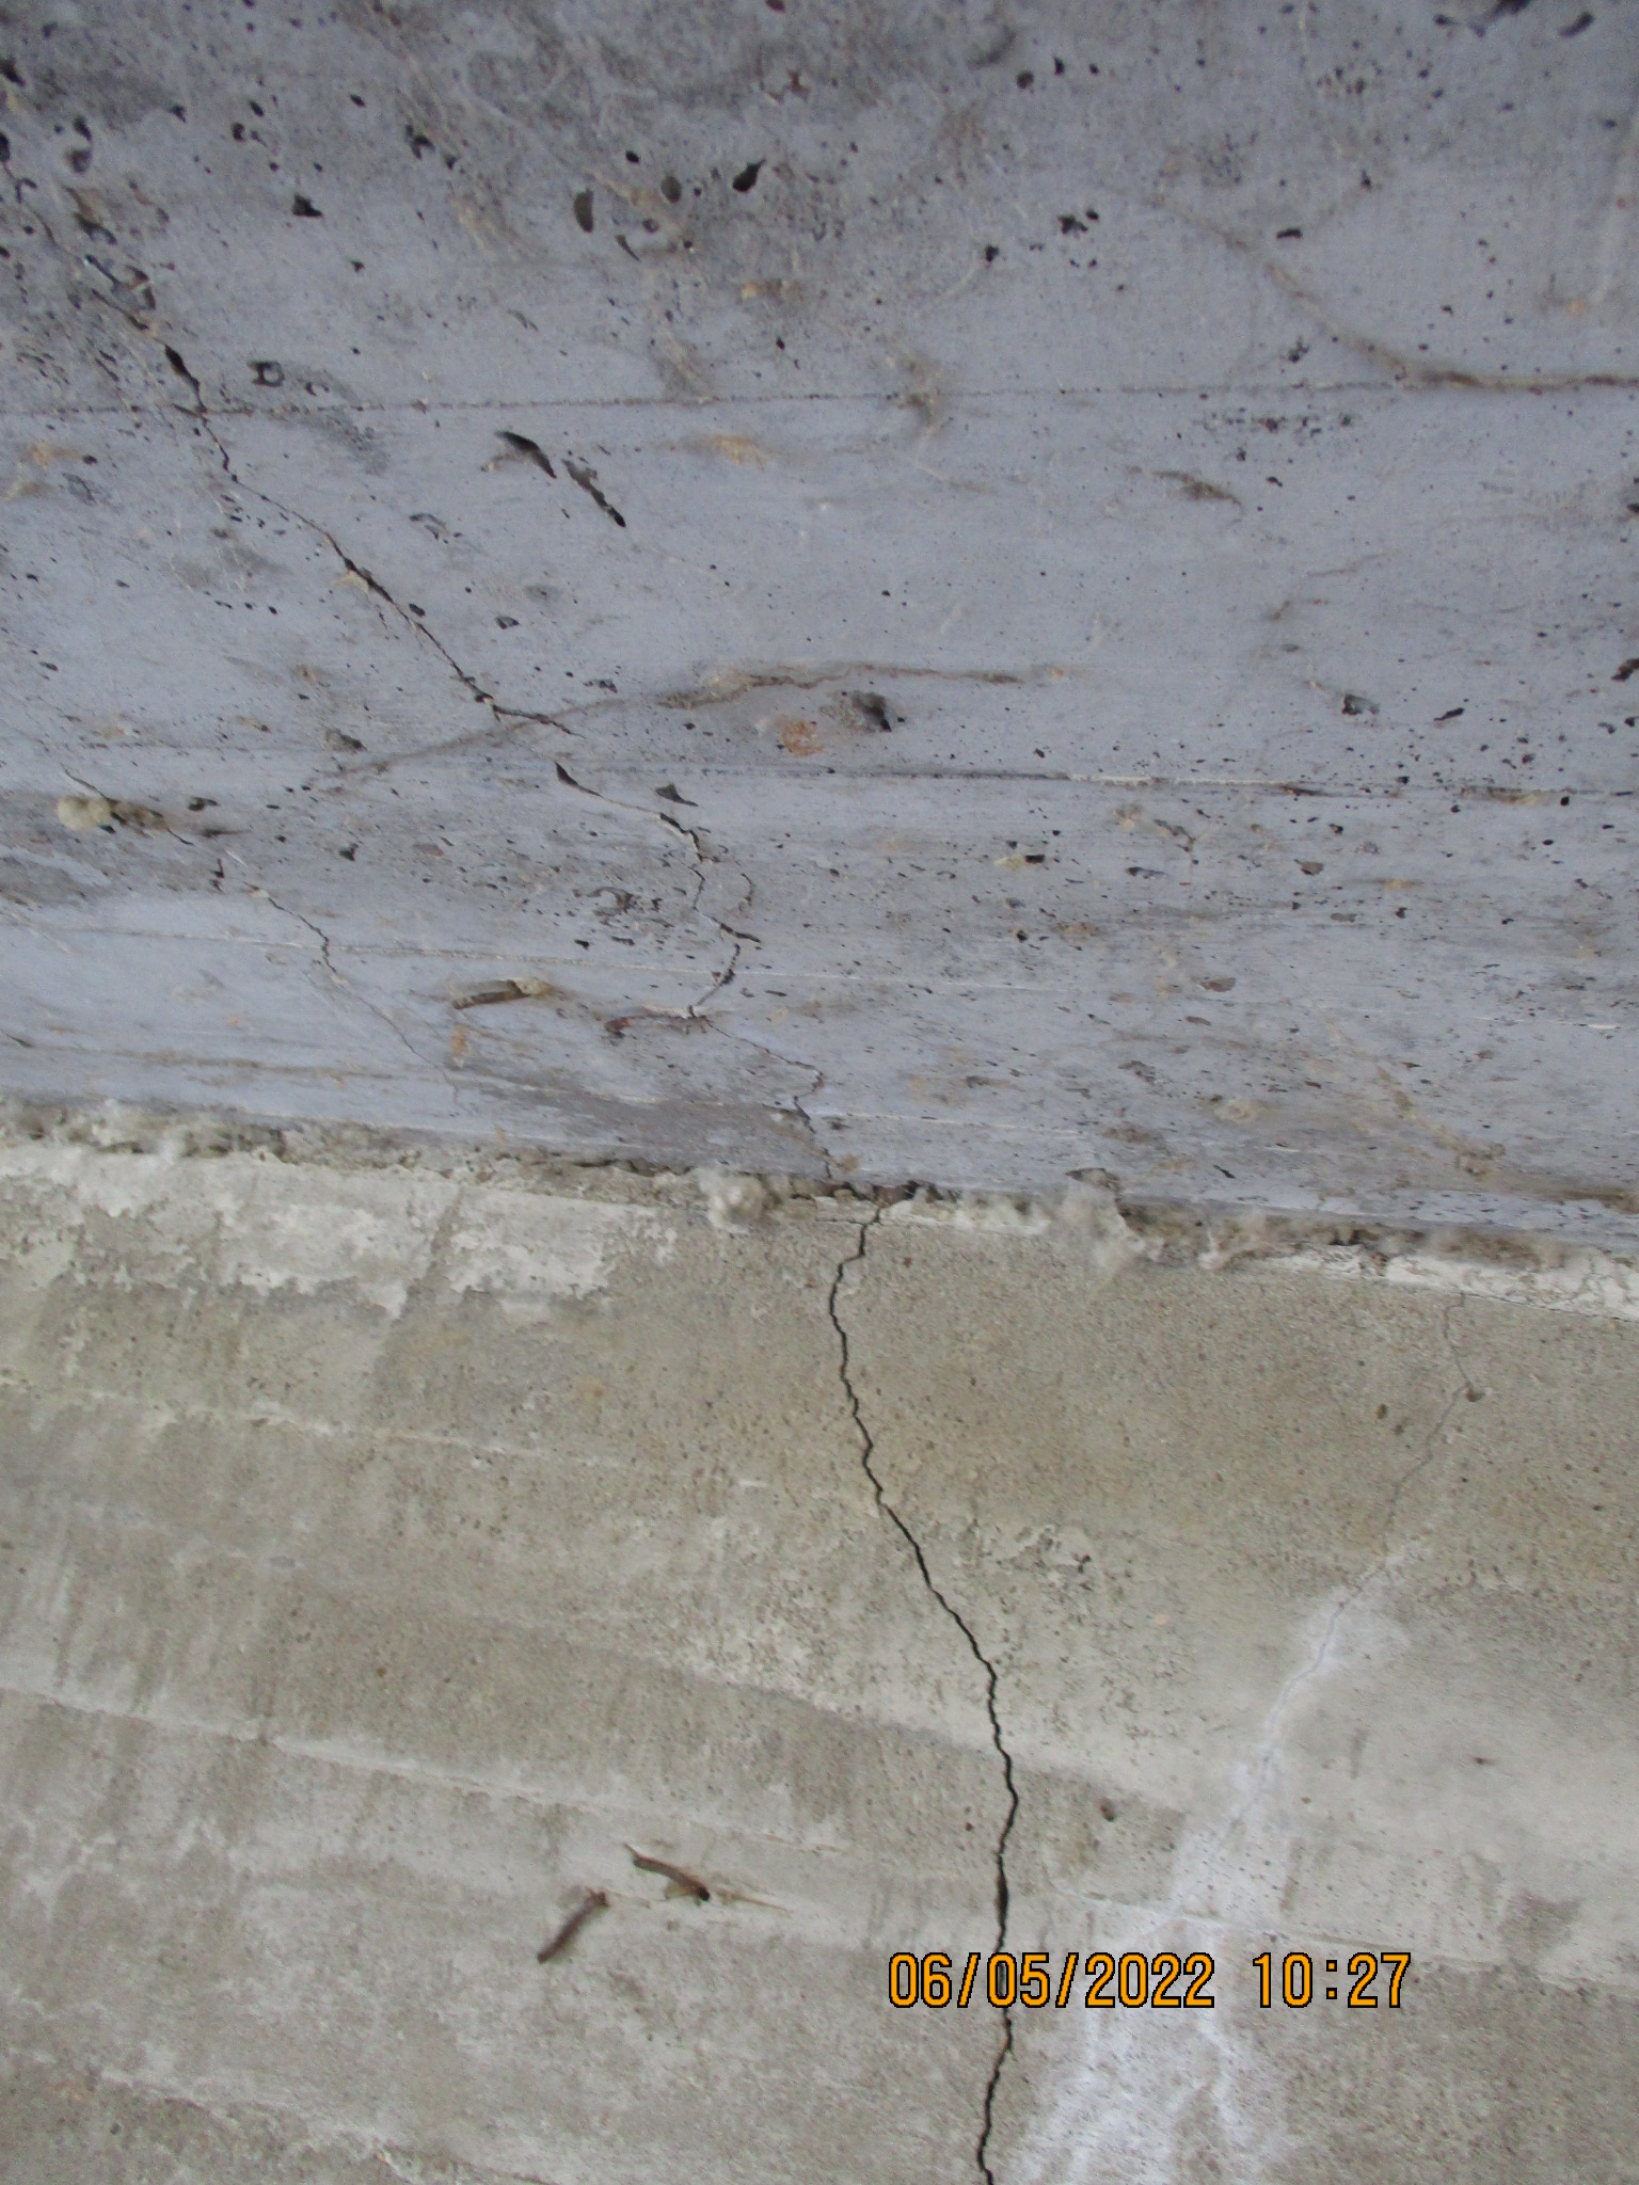
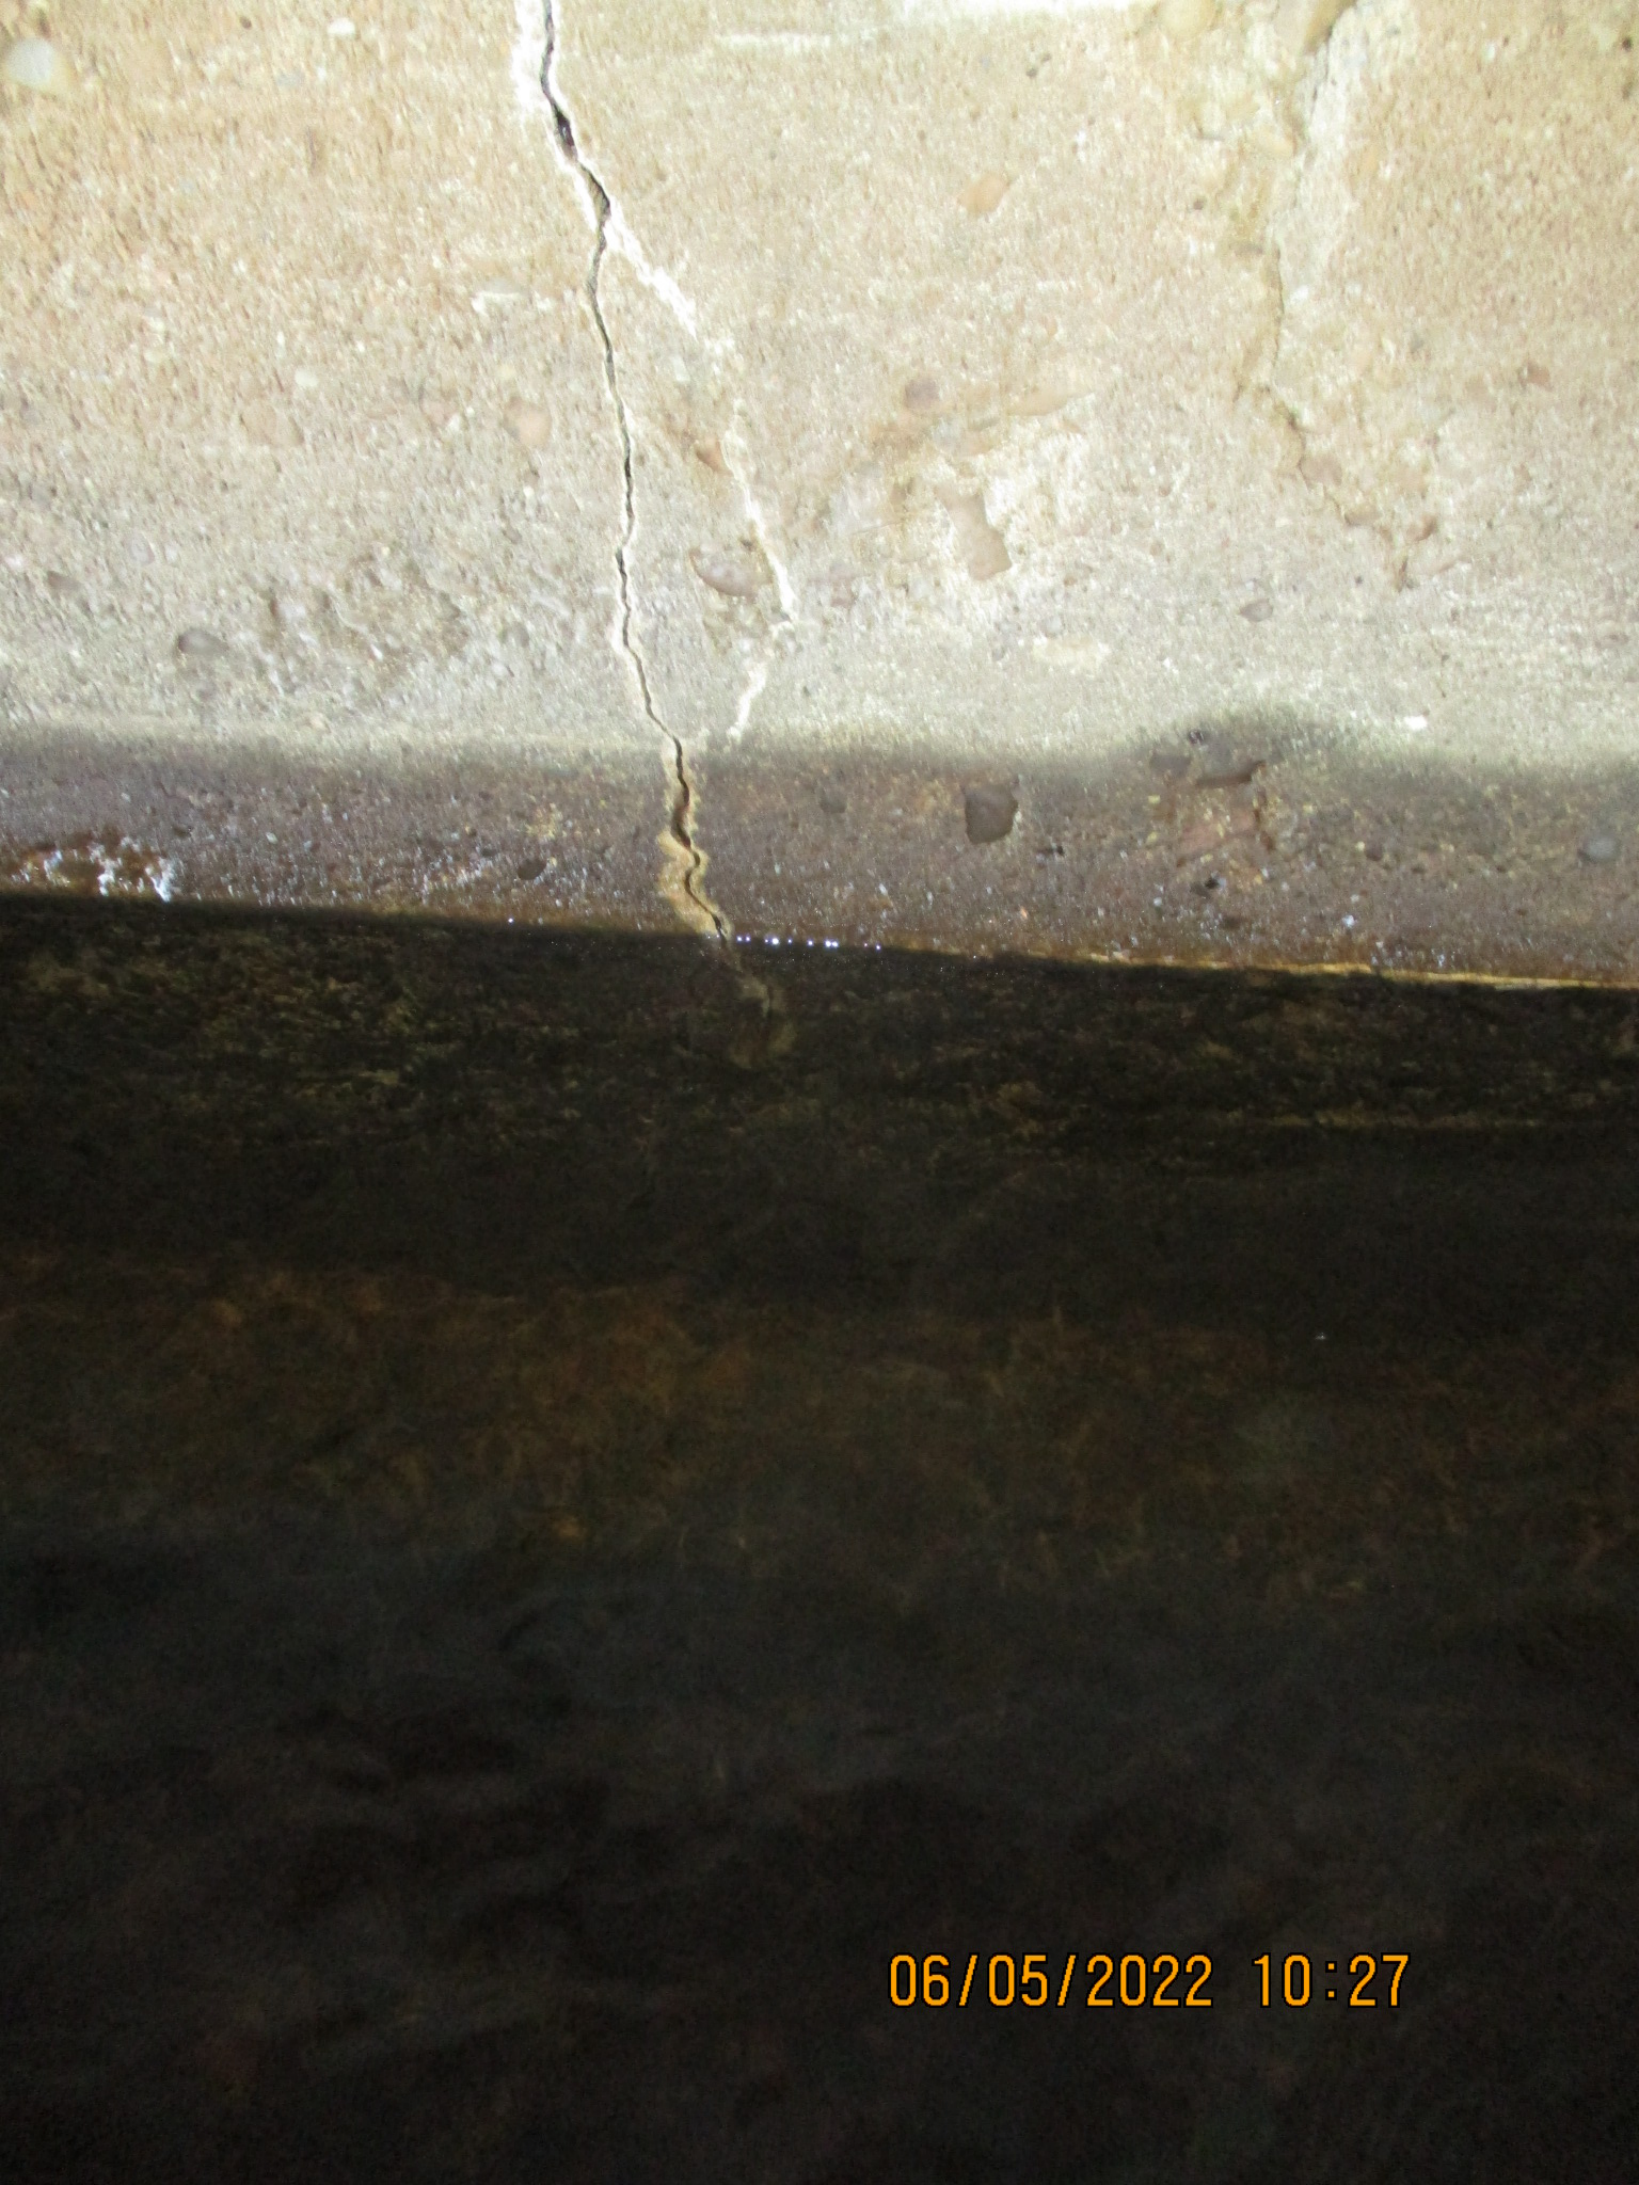
APPENDIX F
RELEVANT PHOTOS

As noted in the OSIM reports and appeared during site visits shows there are a major crack visible on both abutments (east and west) extended into footing and culvert's top slab (see Appendix F). The same crack has propagated from the abutment into the bridge deck. There are no as-built drawings available. However, it can be resolved that the existing footings are resting on the bedrock.

The observed cracks appear as caused by differential settlement of the structure. As noted in investigation notes and reporting in the borehole logs, the rock at the west of the creek is extremely weathered at the surface. It is concluded that founding on extremely weathered bedrock has caused permanent damages to the structure. In the absence of as built drawings it cannot be confirmed, If existing footings are bearing on native soil or on the bedrock.

Since it is foundation issue, crack repairs on the superstructure will not remediate the root cause of the damage. In case of disintegration at foundation level, the structure will be subject to further movement and cracks will appear once more after repair have been completed. The cause of movement can be attributed to seasonal changes, frost action, or due to imposition of considerable unbalanced service loads.

In our engineering opinion, restoration of the bridge is not a viable option, replacement of the bridge in its entirety should be considered.
